Morco's 'Important Safety Warning'

concerning specific open-flued water heater models

Boat Safety Scheme briefing for boat owners

December 2024

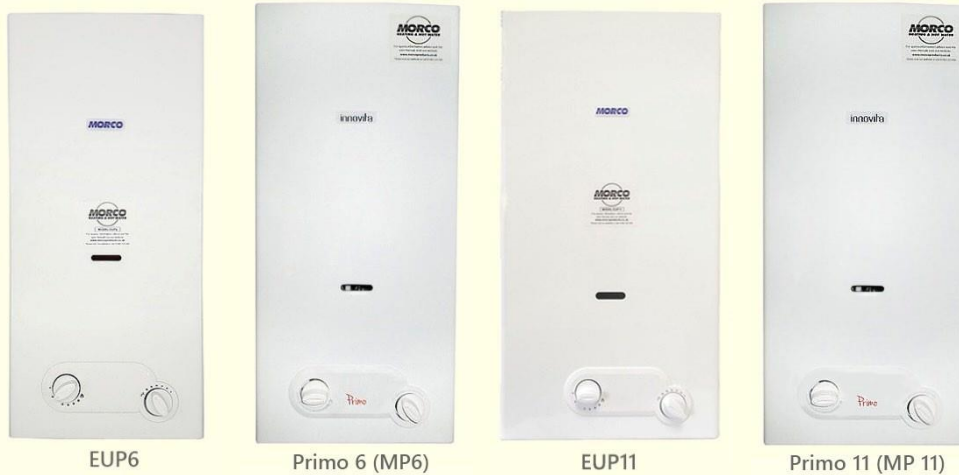
Identifying affected models

These are the front face images of the affected Morco models. some have additional model labels including Innovita and Primo.

Please stop using the water heater immediately and isolate the gas supply to the appliance.

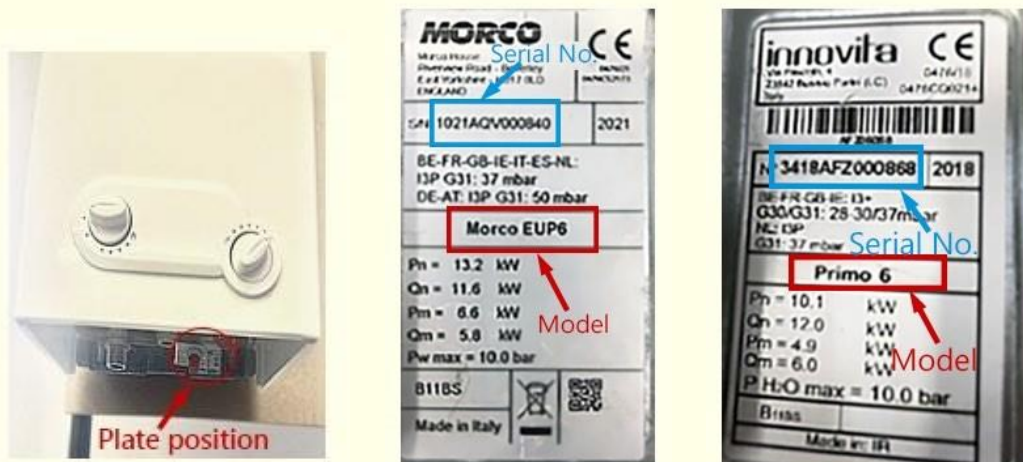
The water heater's data plate indicates the model, serial number and year the appliance was made.

If you look underneath the appliance, you should be able to see this data plate at the bottom of the appliance on the right-hand side of the back plate.

Above are two examples of data plates on the affected water heaters. The model number is highlighted in red. The serial number is in the blue box. The year built is immediately right of the serial number.
